CONNECTICUT
DEPARTMENT
OF
TRANSPORTATION

CONDITION INSPECTION
BRANCHVILLE STATION

**CONN. DEPT OF TRANSPORTATION
STATION INSPECTION**

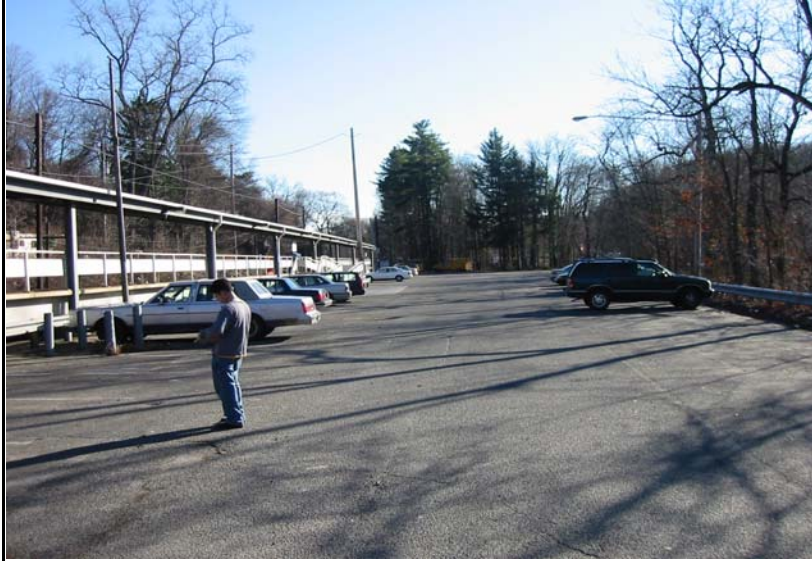
Description: _____
General view of Quad I

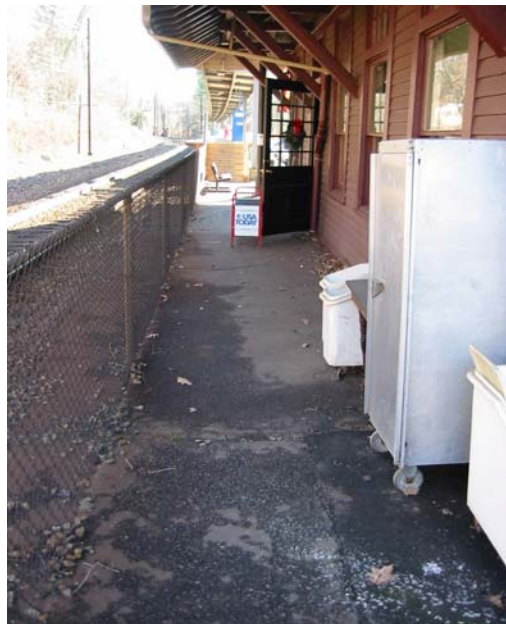
PHOTO NO. 2

Description: _____
General view of Quad II
on the Eastside of the
station house

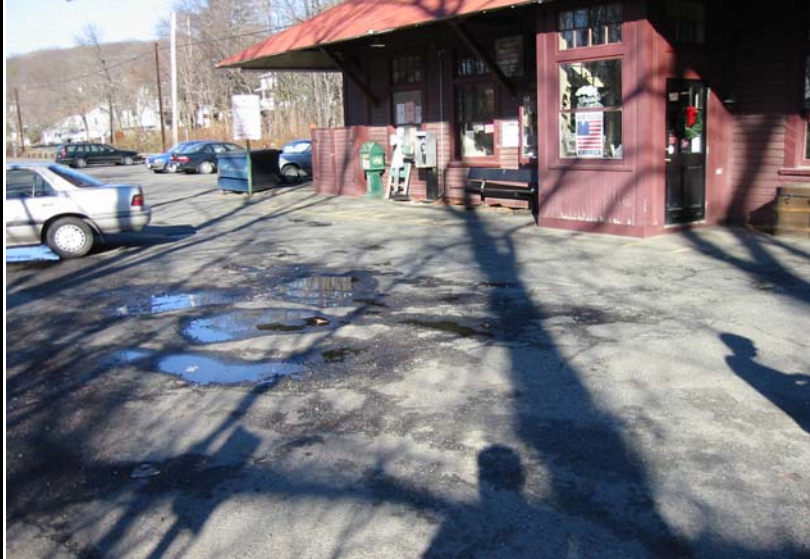
Description: General view of Quad II

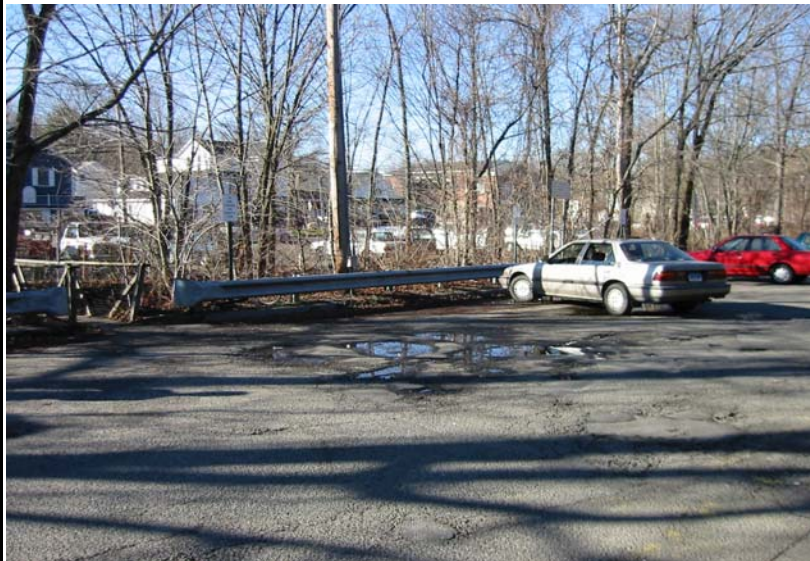
PHOTO NO. 4

Description: General view of Quad II

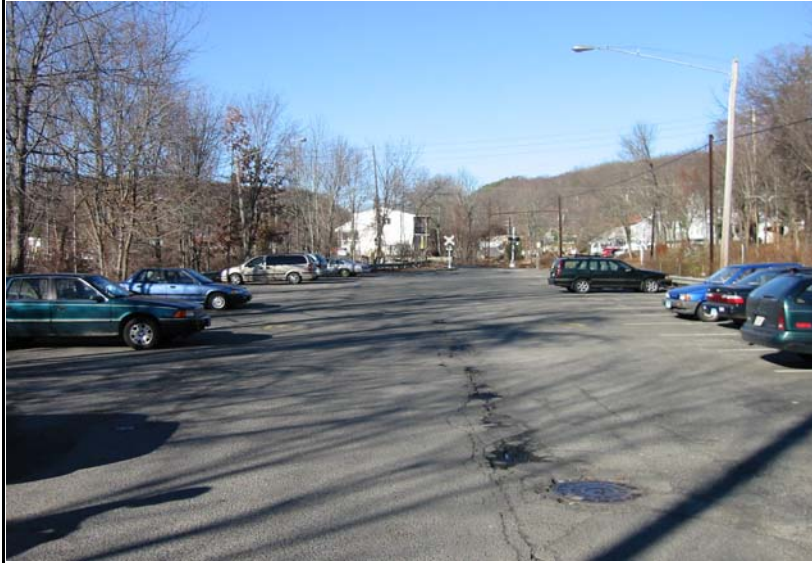
Description:
General view of Quad III

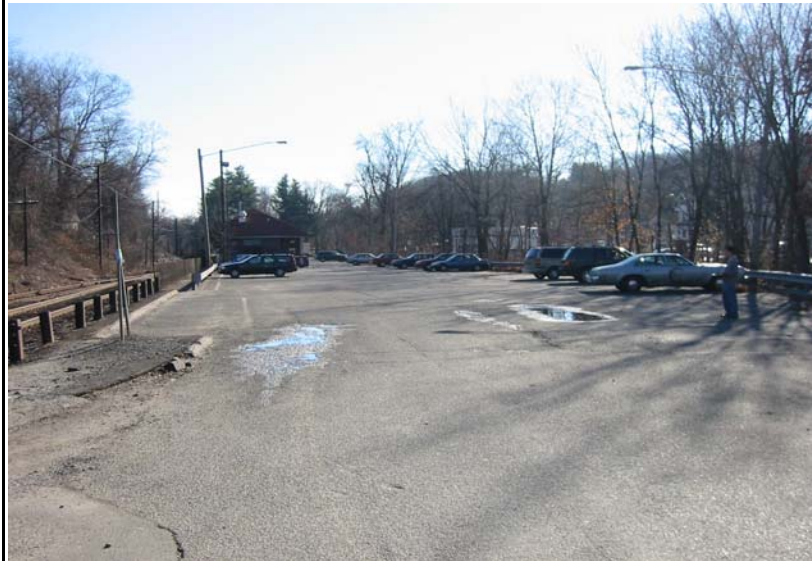
PHOTO NO. 6

Description:
General view of Quad III

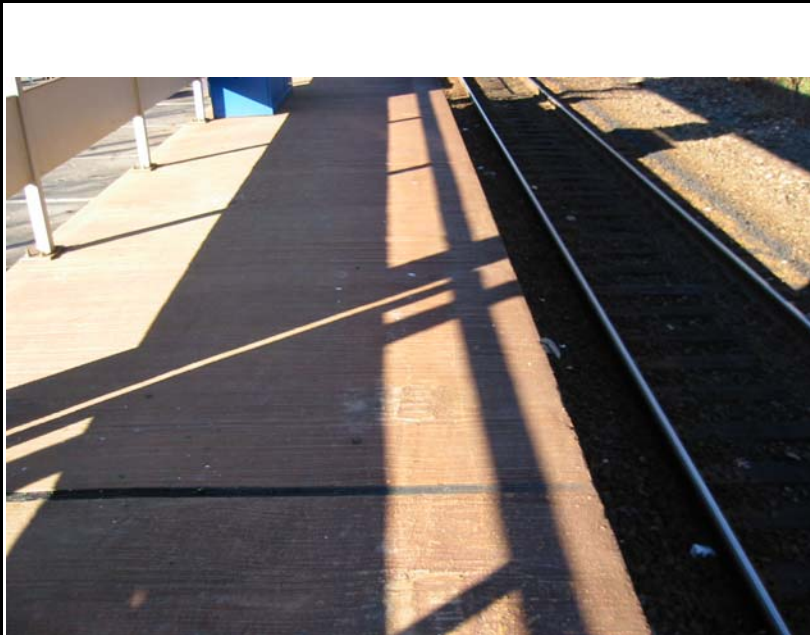
1. The warning strip paint is fading through out the entire length of the platform

Description: _____
The warning strip paint
is faded

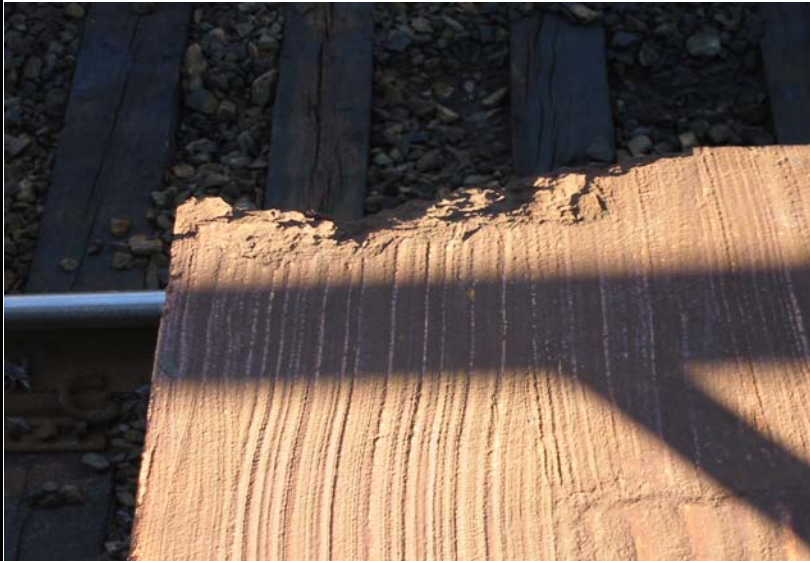
PHOTO NO. 12

Description: _____
Spalled concrete

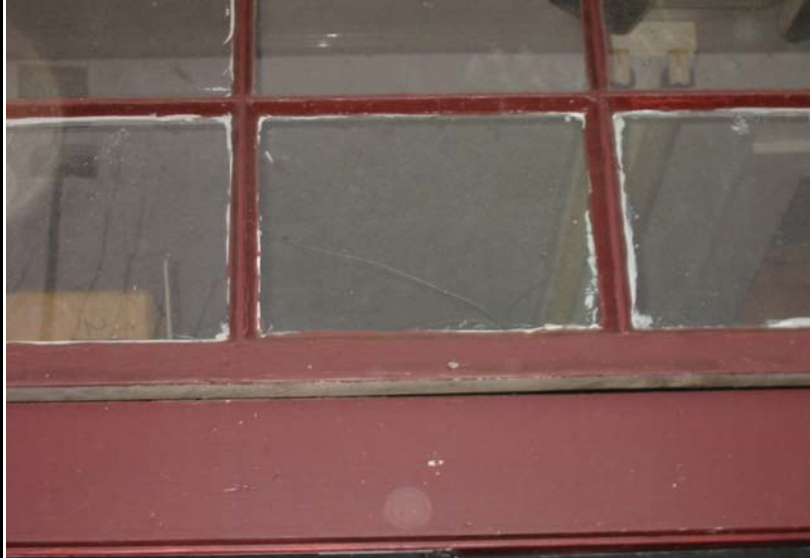
Description: Crack in the Northface window

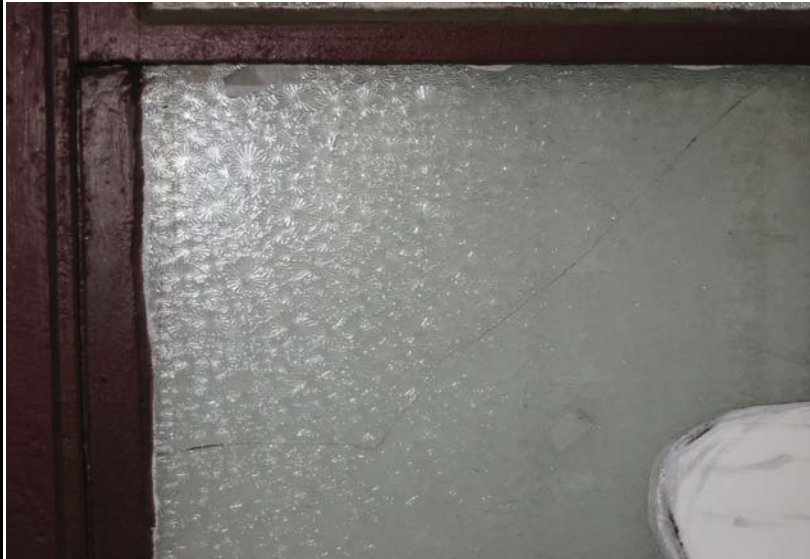
PHOTO NO. 14

Description: Crack in the far north window on the West face of the station house

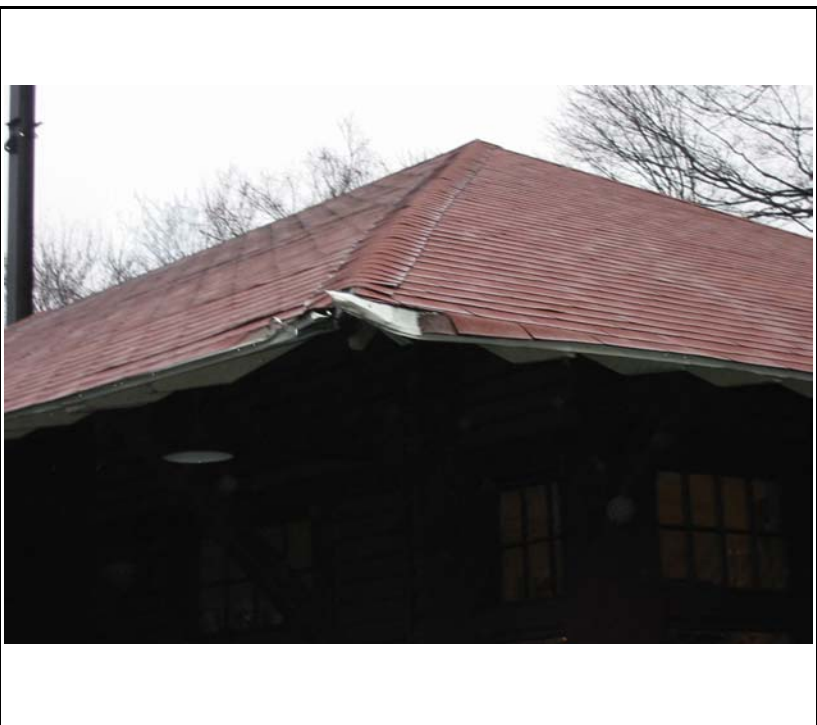
1. The roof is damaged in the Northwest corner, Southwest corner, and the middle of the Westside

Description: The southwest corner of the station house's roof is damaged. Note this occurs on the Northwest corner as well

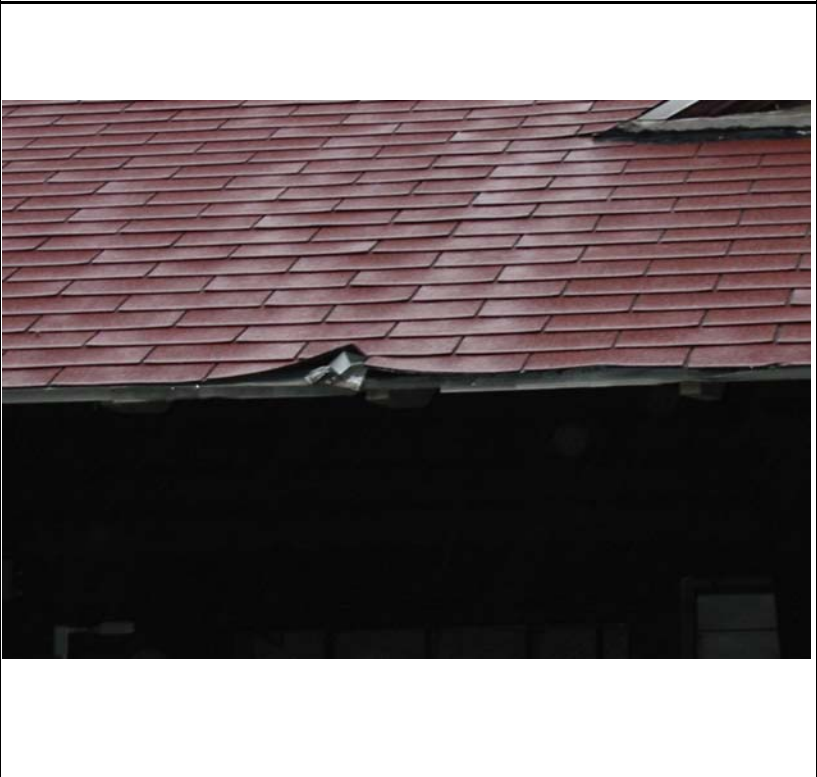
PHOTO NO. 16

Description: Damaged roof at the middle of the Westside of the station house

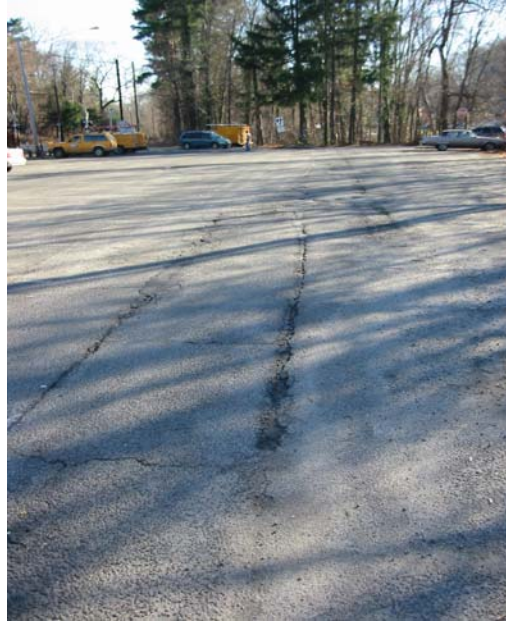
Description: _____
Cracks, and ueven
driving surface.

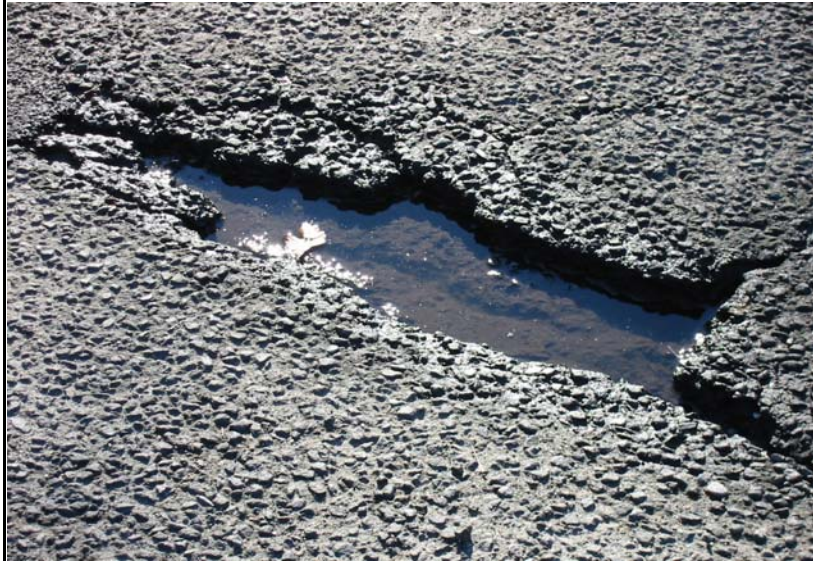
PHOTO NO. 18

Description: _____
pothole with water

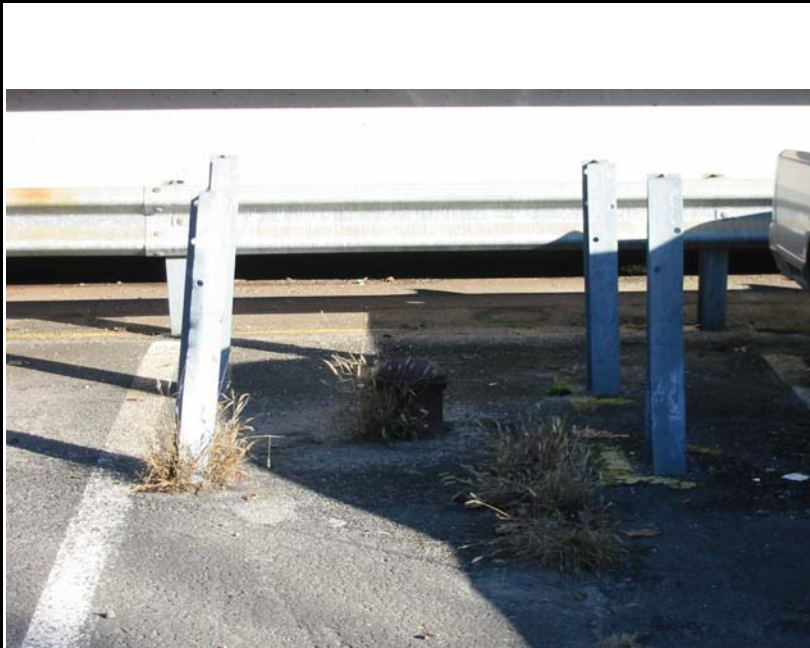
Description: Vegetation growth in
the asphalt pavement

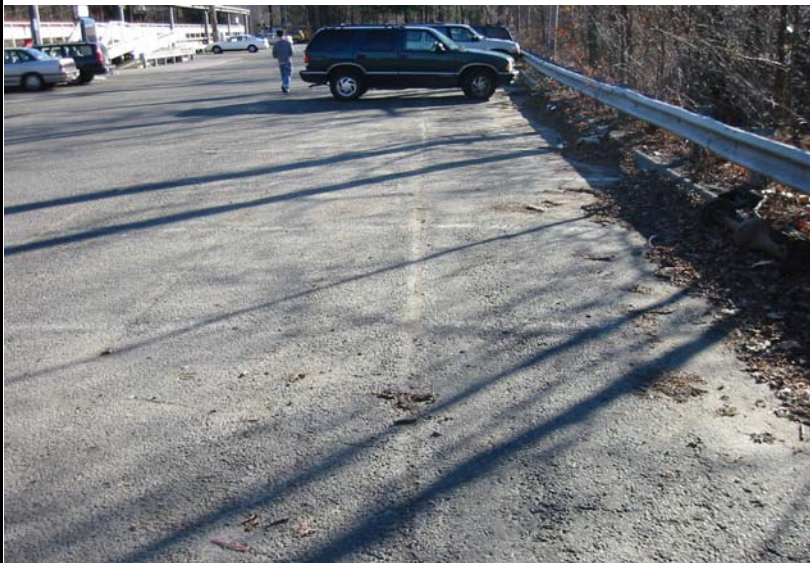
PHOTO NO. 20

Description: Typical faded striping
and overflowing
leaves into the parking
area

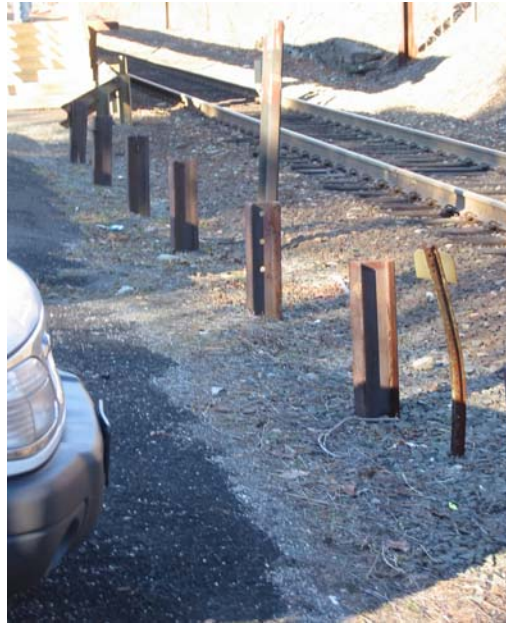
Description: _____
Missing (20') guard-
rail in the Southeast
corner of Quad I

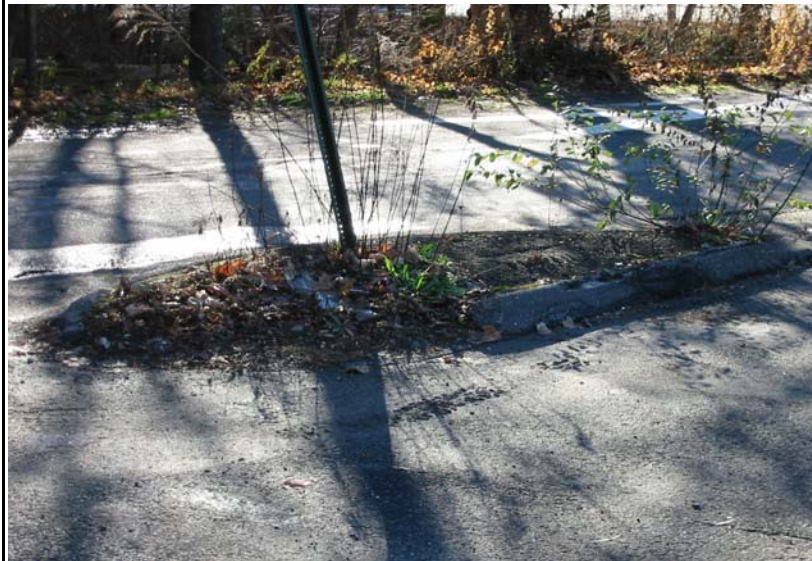
PHOTO NO. 22

Description: _____
Missing (9') asphalt
curb

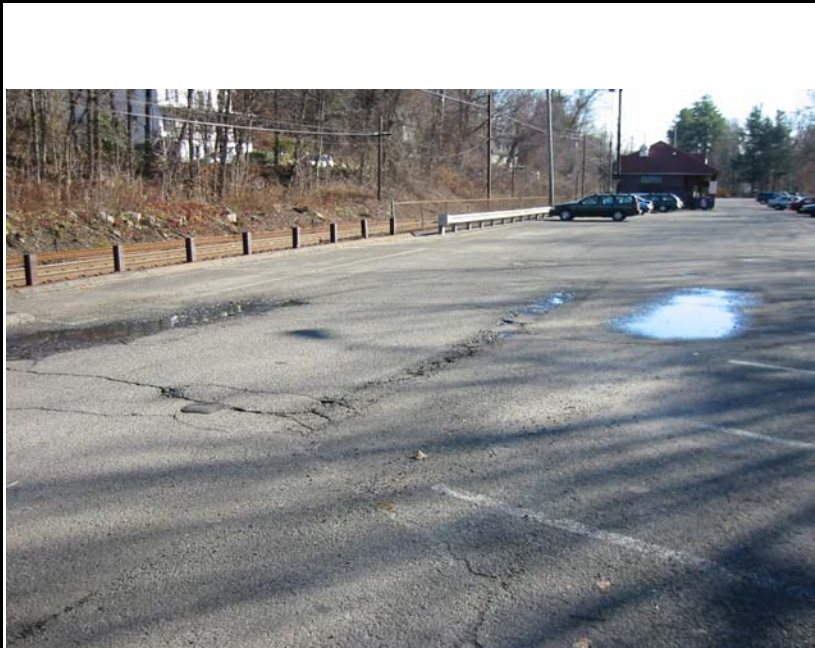
Description: _____
Potholes, cracking,
and ponding

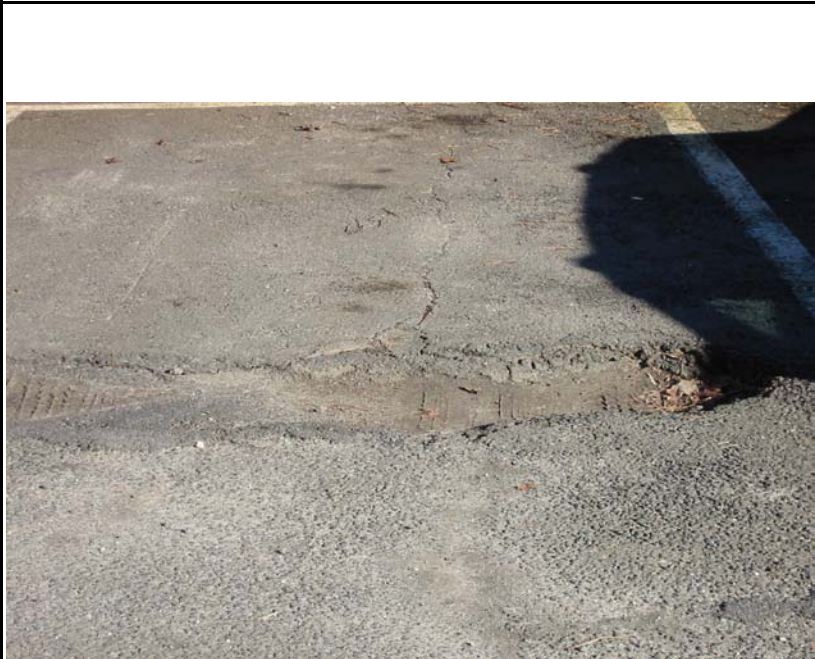
PHOTO NO. 24

Description: _____
Pothole 7'x 2' x5"

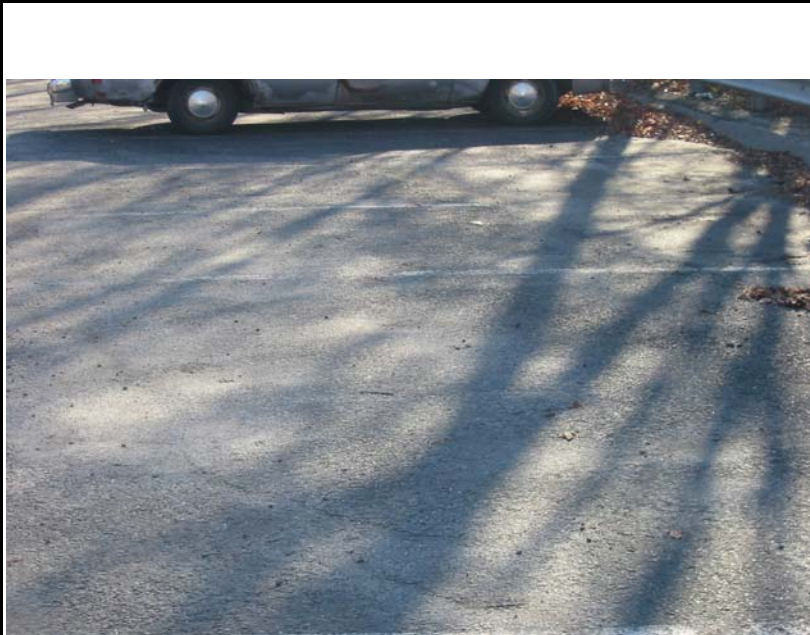
2		25	Quad III	Striping -The striping paint is faded throughout the parking area
1		26	Quad III	Railing -There is 50' of guardrail missing in the notheast corner

Description: Striping is faded

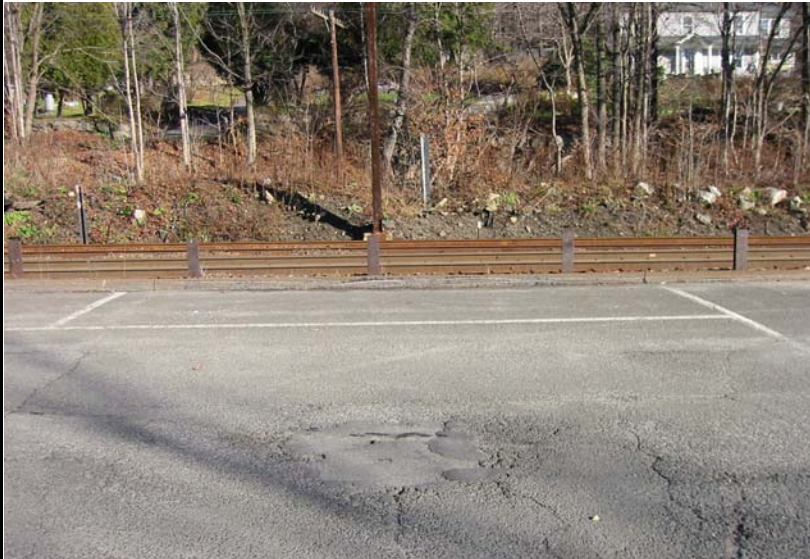
PHOTO NO. 26

Description: Missing (50') guardrail in the North-east corner of Quad I

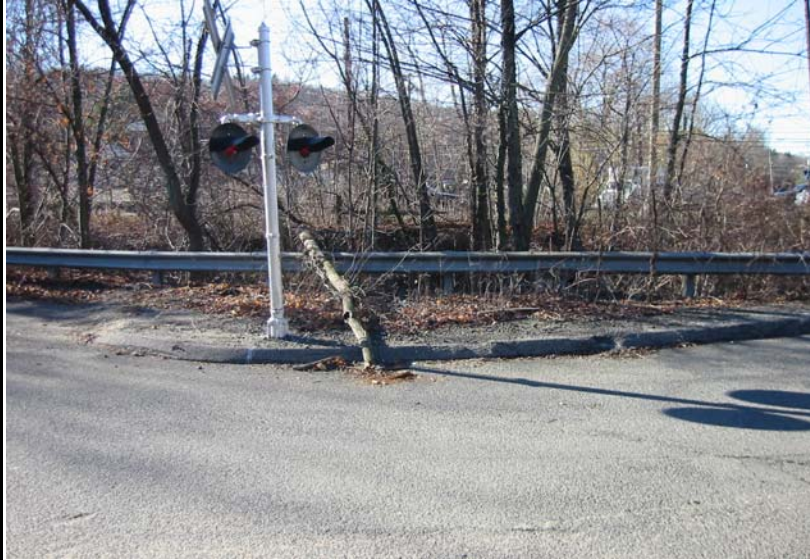
Description: A tree has collapsed onto the railing and into Quad III; Note that the curb is cracked, spalled (5'), and missing (5')

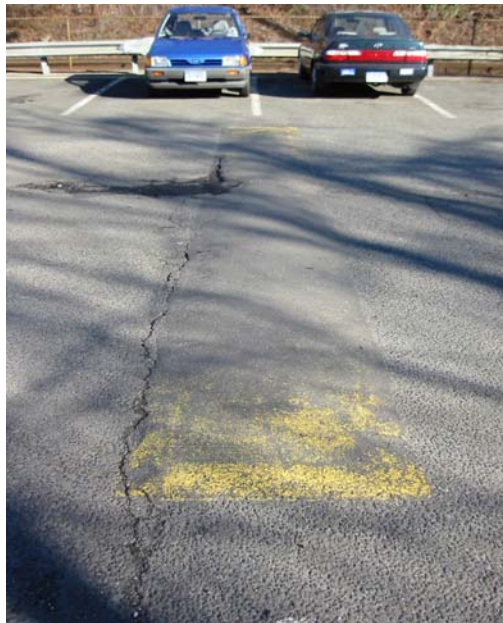
PHOTO NO. 28

Description: The paint is faded which makes it difficult for the driver to see the location of the speed bump approaching

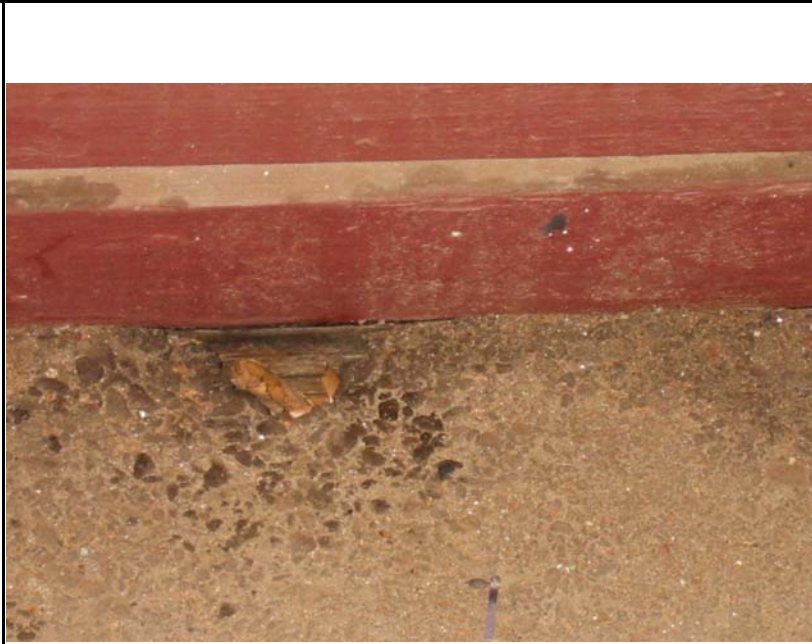
Description: 4" dia hole in the asphalt where it meets the face of the building

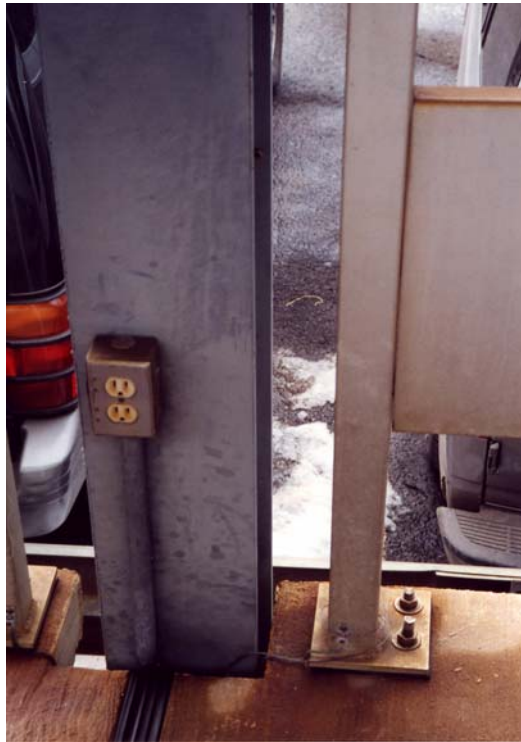
Remarks: The receptacles are not GFCI and mostly broken.

The platform power originates at the building with a couple of circuits for the platform receptacles and platform lighting. The few non-GFCI receptacles are missing their covers and exposing people to possible electric shock. We suggest that the receptacles be replaced with GFCI type with covers.

Description:
a typical
receptacle with a
missing cover

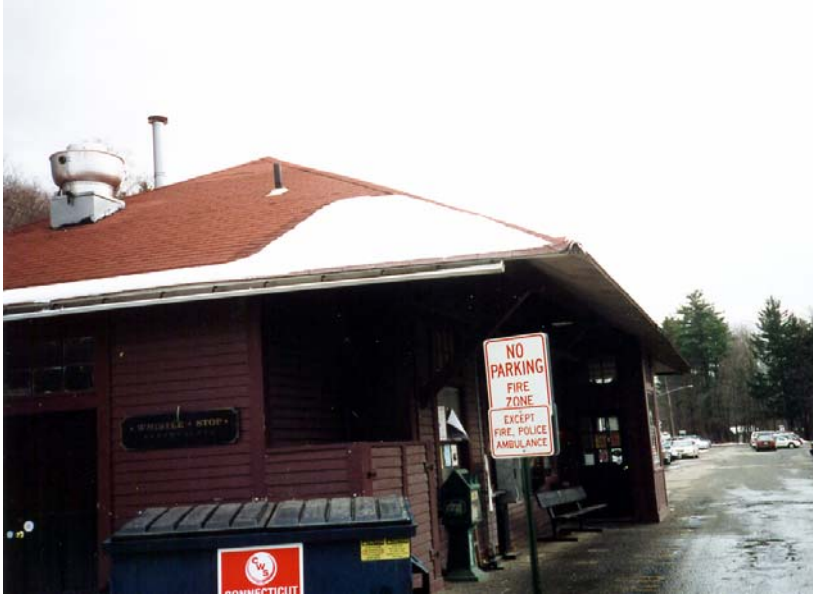
PHOTO NO. 39

Building gutters are missing all along front and side of the building.
The rest of the gutters and downspouts where they existed are severely deficient.

The building gutters and downspouts are missing all along the front and side of the building. The other gutters and downspouts on the building are in disrepair. Gutter and downspouts should be installed.

Description:
Kitchen fan
on the roof,
missing
gutters on
the building
